Serviceability

Serviceability Limit States – study case

Department store in Prague

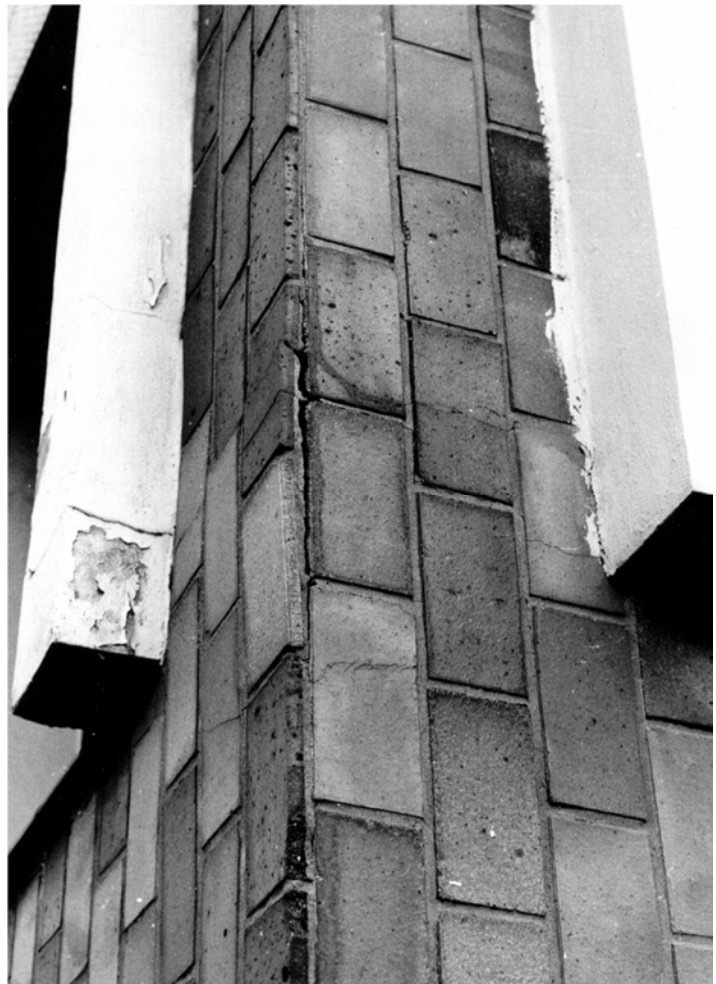
Cracks in
the facade
corner

- The structures was strong enough but not serviceable
 - Lack of considerartion of deformations in design
 - large internal spans (12 x 12 m)
 - large cantiliveres (3 m)
 - differential deflections
 - effects of creep, shrinkage and temperature
 - Construction errors:
 - unencouraged cantilivere ties
 - excessive permanet load of the roof
 - Errors in use:
 - overloaded storaged spaces

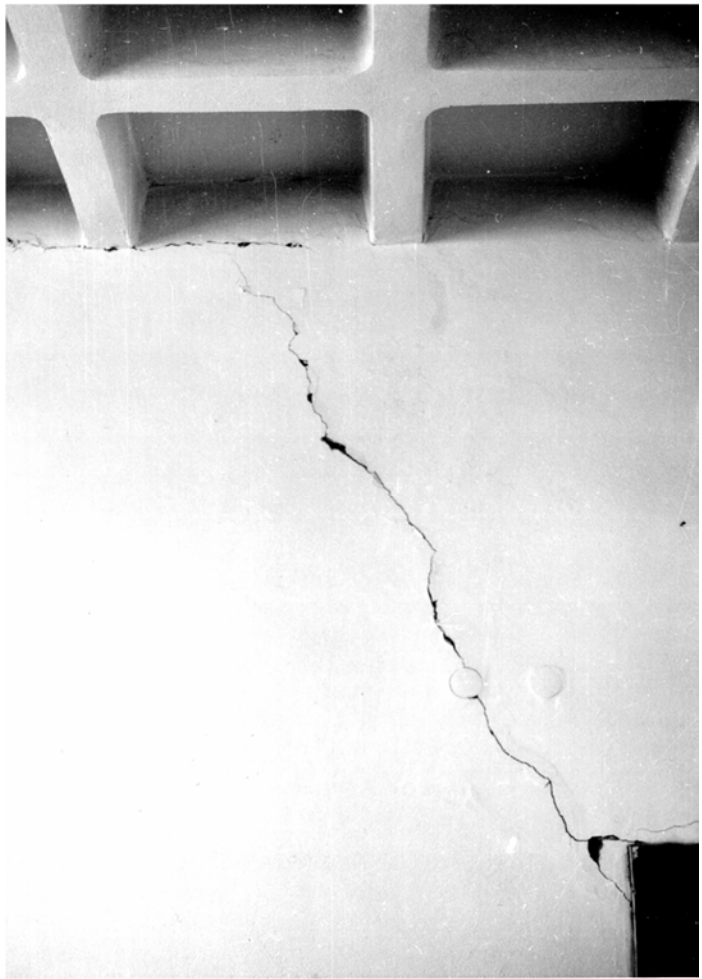
Cracks in
a partition wall

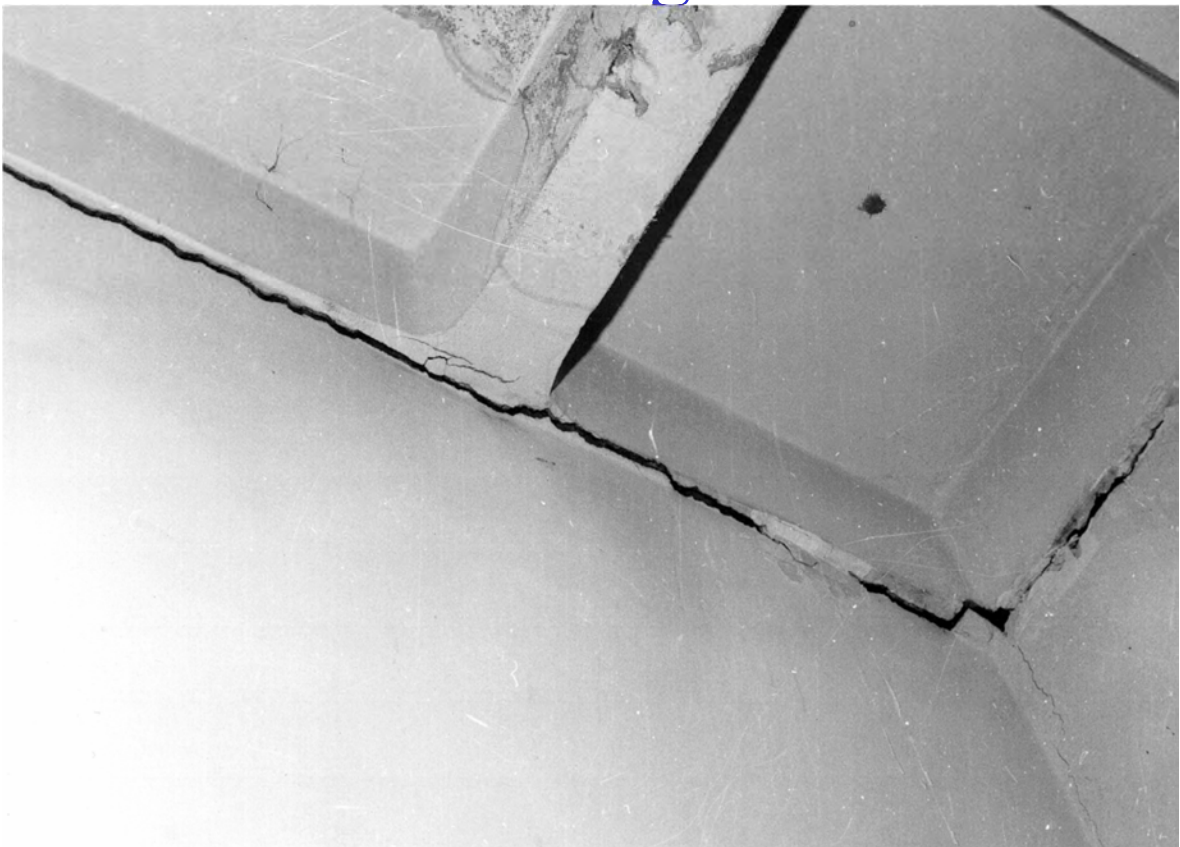
Separation of partition walls from
ceiling

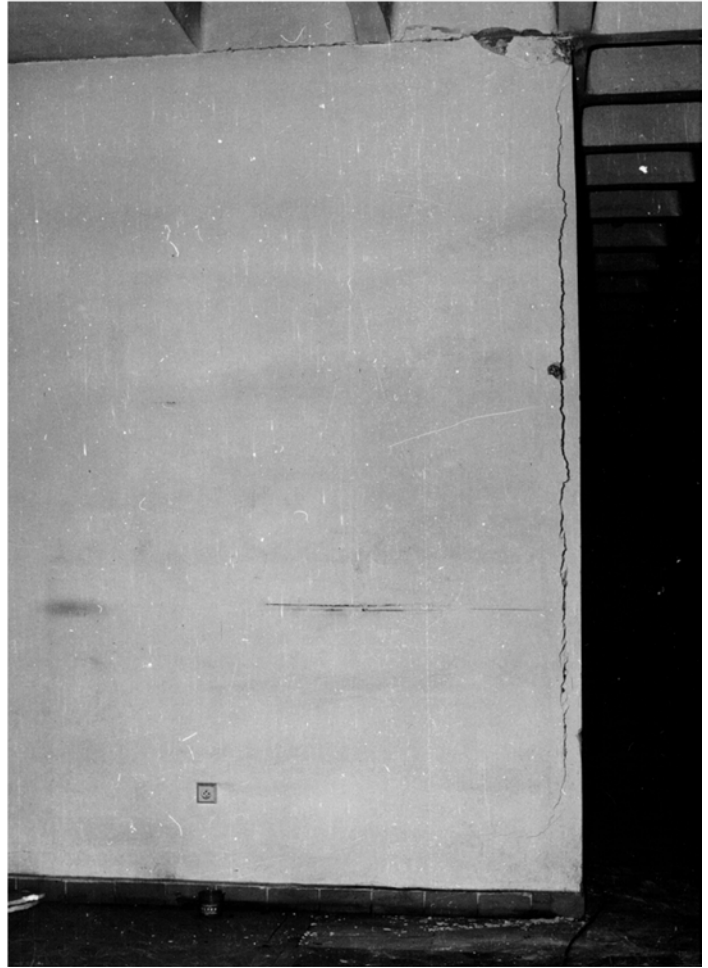
Separation
of steel
profile
from a
partition
wall

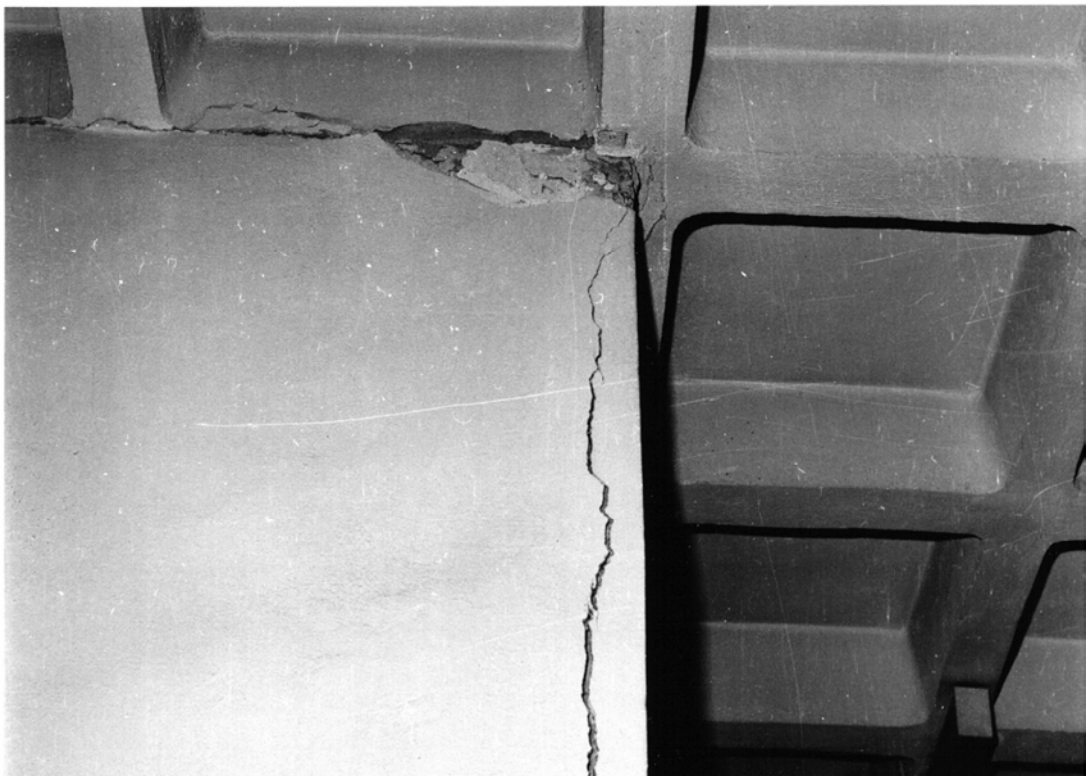
Cracks in a partition wall

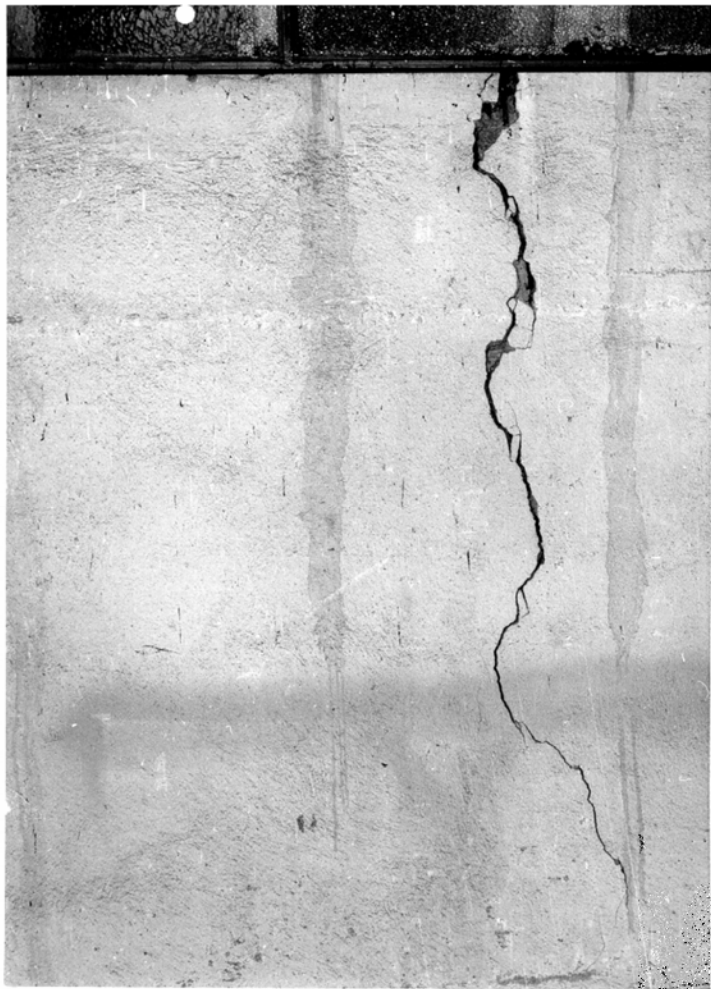
Department
store in
Prague
cracks in
a cladding wall
nearby both
ways
cantilivered
corner
